**RE: 2018 SPAM chip Seal Study**

Lockwood, Andrews & Newnam, Inc. (LAN) was contracted by the City of Schertz for performing a study on the 2018 SPAM chip seal projects and providing recommendations to mitigate the existing issues including chip loss, raveling, and rough ride.

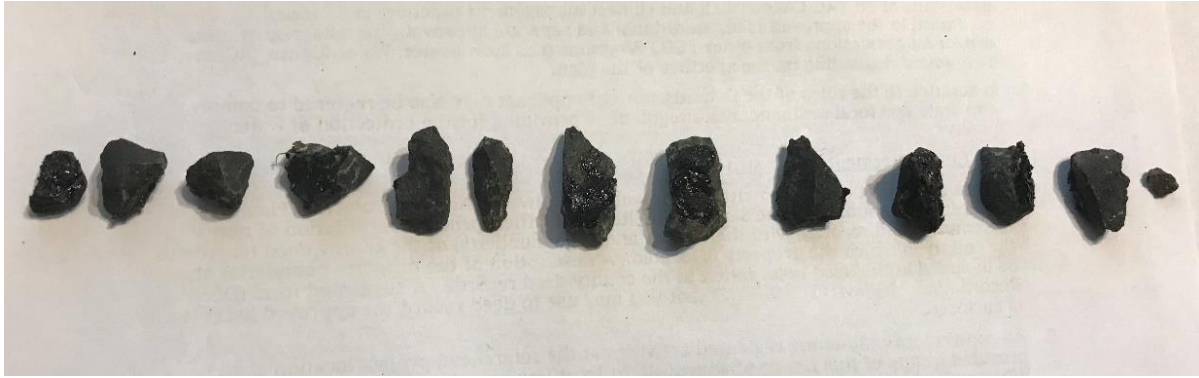
To achieve a consistent embedment depth, aggregates better to be more cubical than being elongated and flat. The flakiness index plays an important role in the performance of a chip seal project. The contractor's submittal does not show the flakiness index but according to the chip samples collected, the flakiness index of aggregates seems to be high. Figure 1 shows the samples collected from Gwendolyn Way. As can be seen, most of the samples are very flat and elongated.

Figure 1- Chip samples from Gwendolyn Way

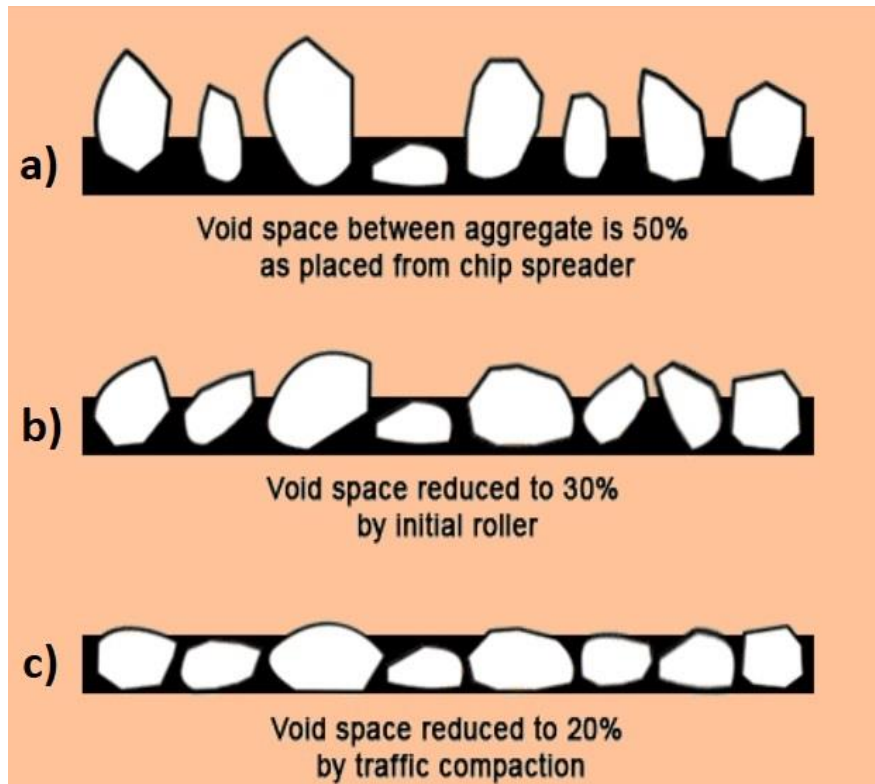
The low percent embedment can be a result of low asphalt binder application rate or poor compaction. There are two phases of compaction in chip seals; the first phase is the initial compaction by roller and the second phase is the final compaction caused by traffic. Small dead-end streets do not have enough traffic to compact the chips sufficiently, therefore, a higher binder application rate is required for those streets. Figure 2 shows the positions of aggregates throughout the compaction phases.

Figure 2- compaction phases of chip seals

As mentioned in section 2.3, a good portion of aggregates in streets with a high amount of raveling seem to be not fully sitting on their flattest side. According to site observations, most of the aggregates are positioned similarly to what is shown in Fig 2(b). Under traffic movement, aggregate particles will rotate until they sit on their flattest sides. That is why it is recommended to start chip seal projects in the early construction season, so it allows chips to rotate while the binder is soft during the hotter weather.

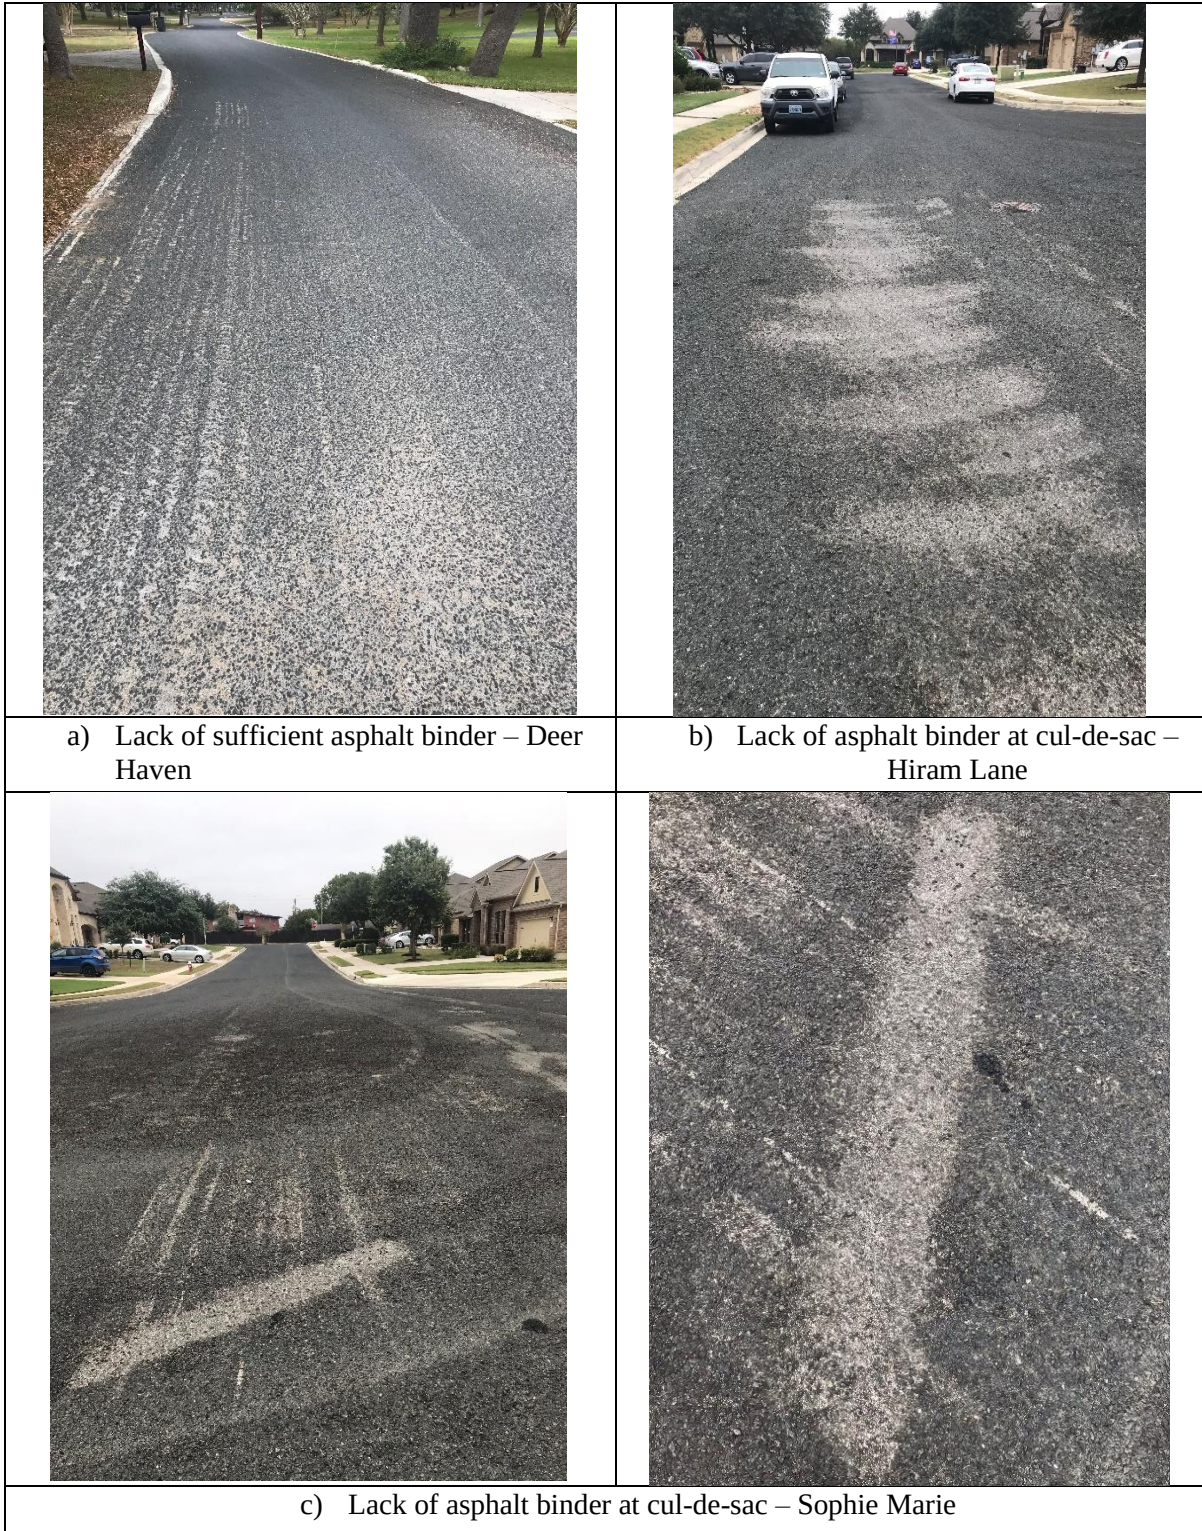
As can be seen in Figure 3, there are many parts of the streets where the old pavement surface is fully exposed without the presence of emulsified asphalt binder. Figure 3(a) shows parallel lines with aggregate loss along the street. This can be due to equipment (distributor) nozzles not being calibrated or adjusted. Almost in all streets with regular cul-de-sacs or elbow-type cul-de-sacs, nonuniform application of asphalt binder was observed. This resulted in zero to low asphalt binder in some areas and excessive asphalt binder in some other areas in the vicinity (Figures 4 and 5).

Figure 3- Exposed pavement surfaces on chip seal projects

For streets with light raveling, LAN does not recommend any treatments at this moment as we believe the chip loss would stop soon. On streets with medium to high raveling, our short-term recommendation is to apply a slurry seal over the existing chip seal. The final product is called Cape Seal. We also recommend applying a fog seal or tack coat on cul-de-sacs prior to applying the proposed slurry seal; this can provide a better bonding and would prevent delamination in the next few years.

The long-term solution is milling out the existing chip seal in addition to about 1” of the old pavement and place 1.5” of a HMA overlay. This method would cost more than the first proposed method (applying slurry seal), but the final product would last much longer.

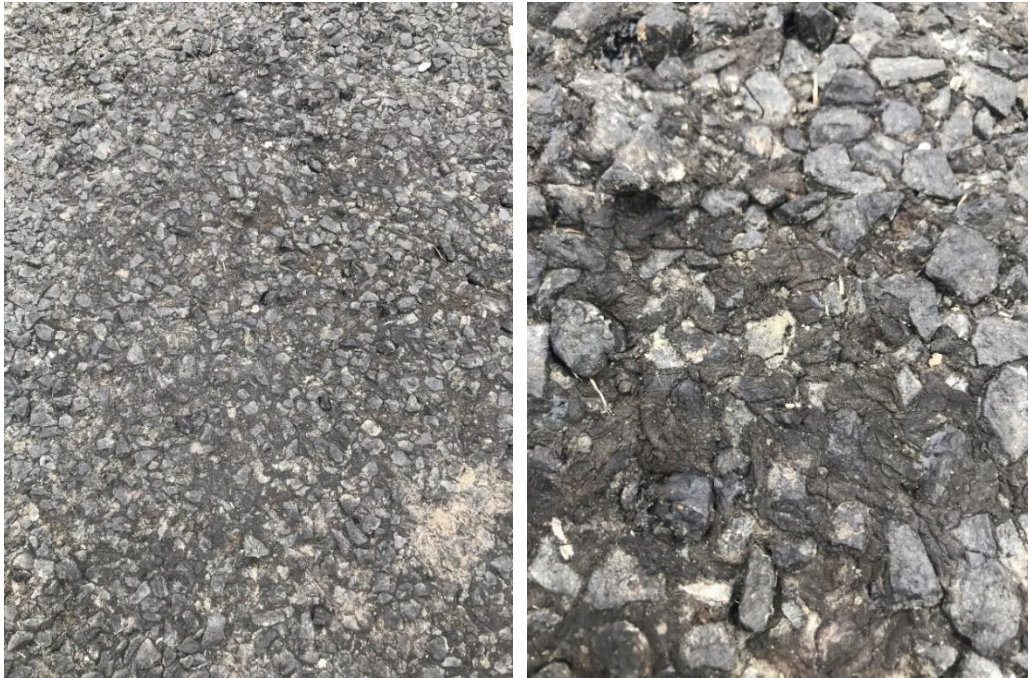
Figure 4- Excessive asphalt binder (Flushing) at cul-de-sac – Sophie Marie

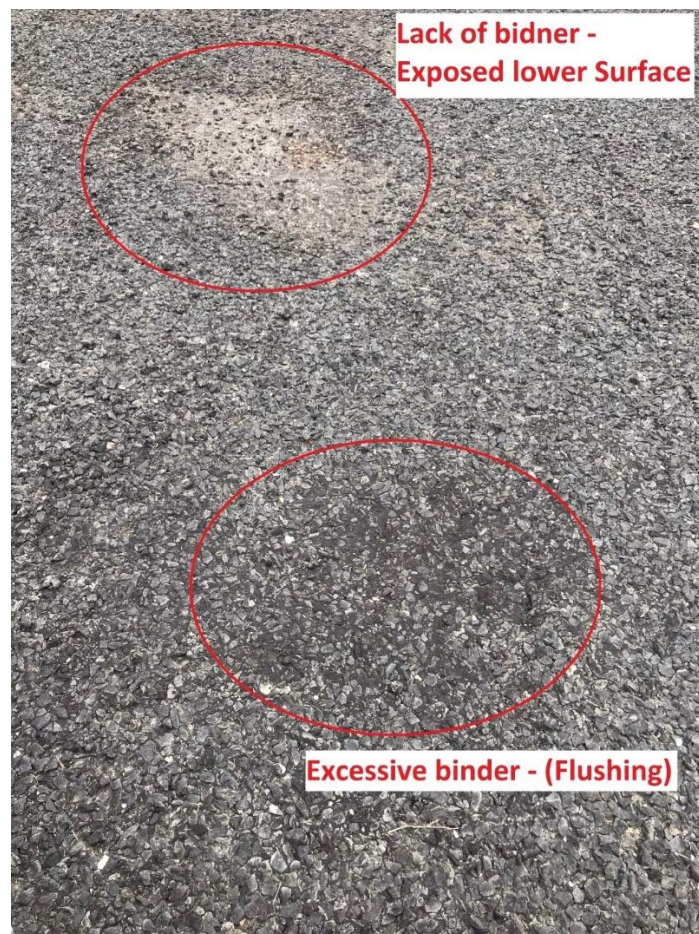
Figure 5- Nonuniform asphalt application - Hiram Lane

In these cases, initially, only a few chips will be missing, then it becomes a progressive issue. The loss of these few chips seriously weakens the shoulder-to-shoulder bracing of the chips, which is as important as the grip of the binder in holding the chip in place. The result is more chip loss that further weakens the seal. In any road with significant traffic, the whole process can progress from 1% or 2% loss to complete chip loss over half or more of the surface in a matter of weeks or over several months.

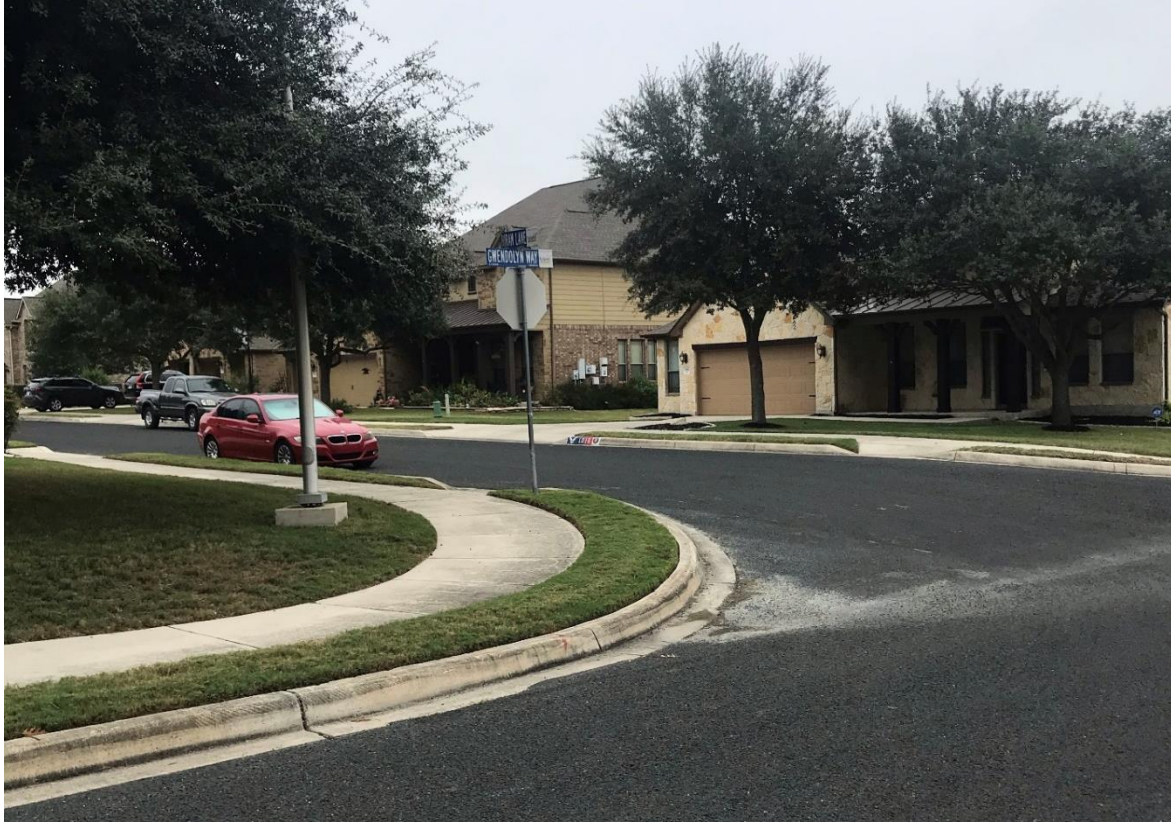
According to the field observation, almost in all intersections, the lower pavement surface was exposed which is due to the stop-start traffic, particularly on up or downhill sections of roads, and heavy braking and acceleration. Technically, these areas need more attention during the construction in terms of asphalt application rate and compaction.

Figure 6- Severe chip loss at the corner of Gwendolyn Way and Hiram Lane
